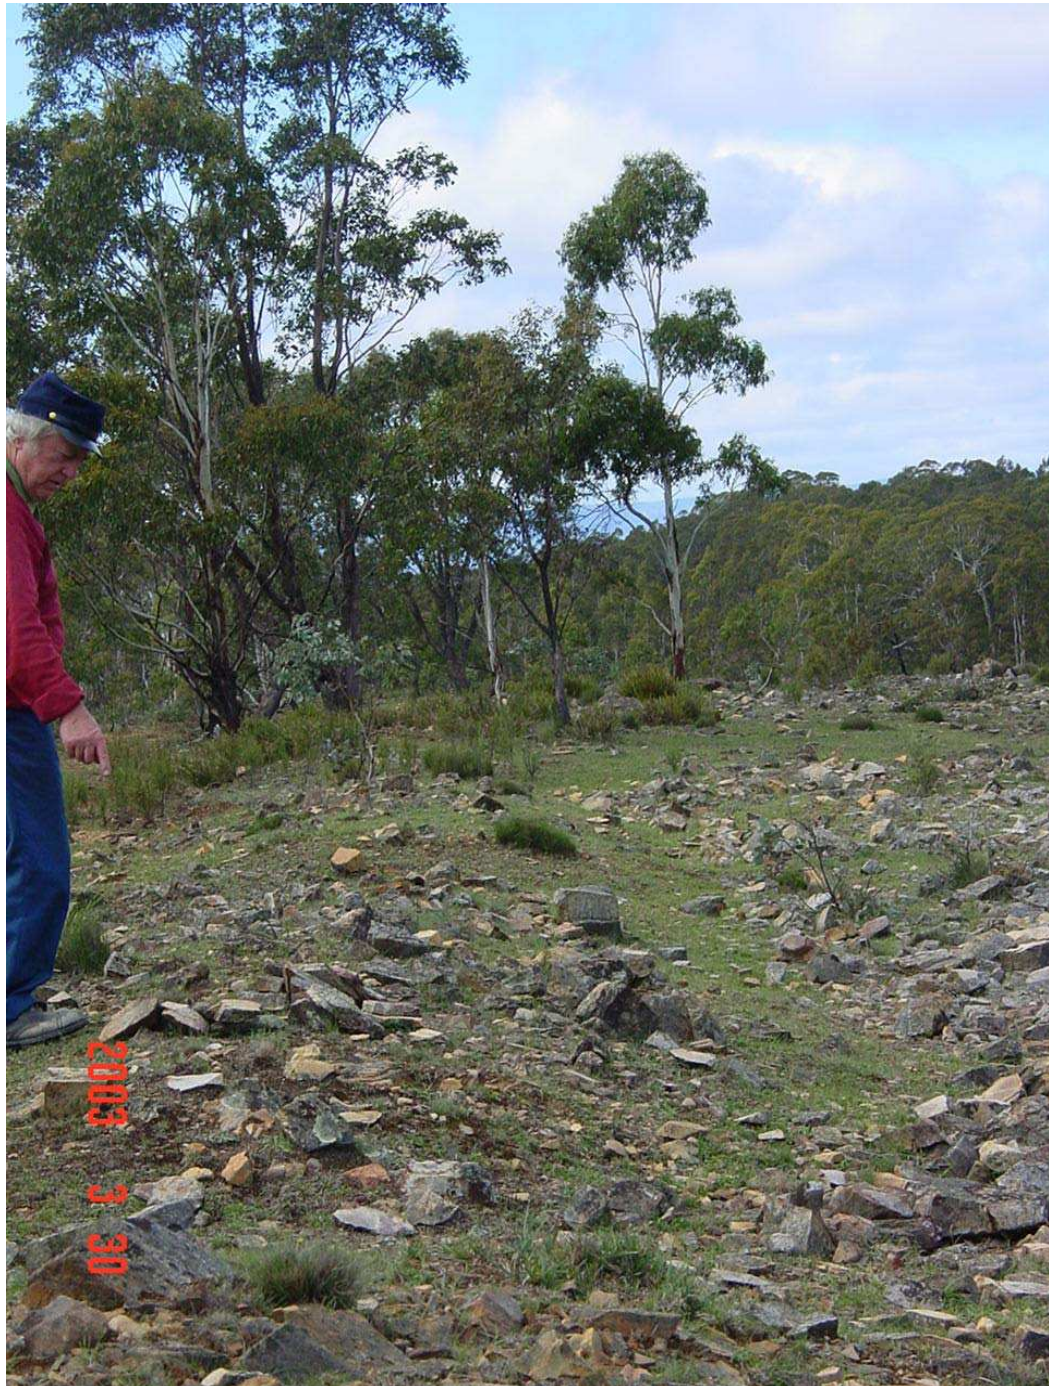
Figure 3.3 Pictured are angular rocks along the line of road on the Honeysuckle Range in 2003. These are remnants from the macadamising process (the term derived from MacAdam's name) which involved successive layers of graduated broken stone that became increasingly fine toward the surface. [S. Rosen, 2003]

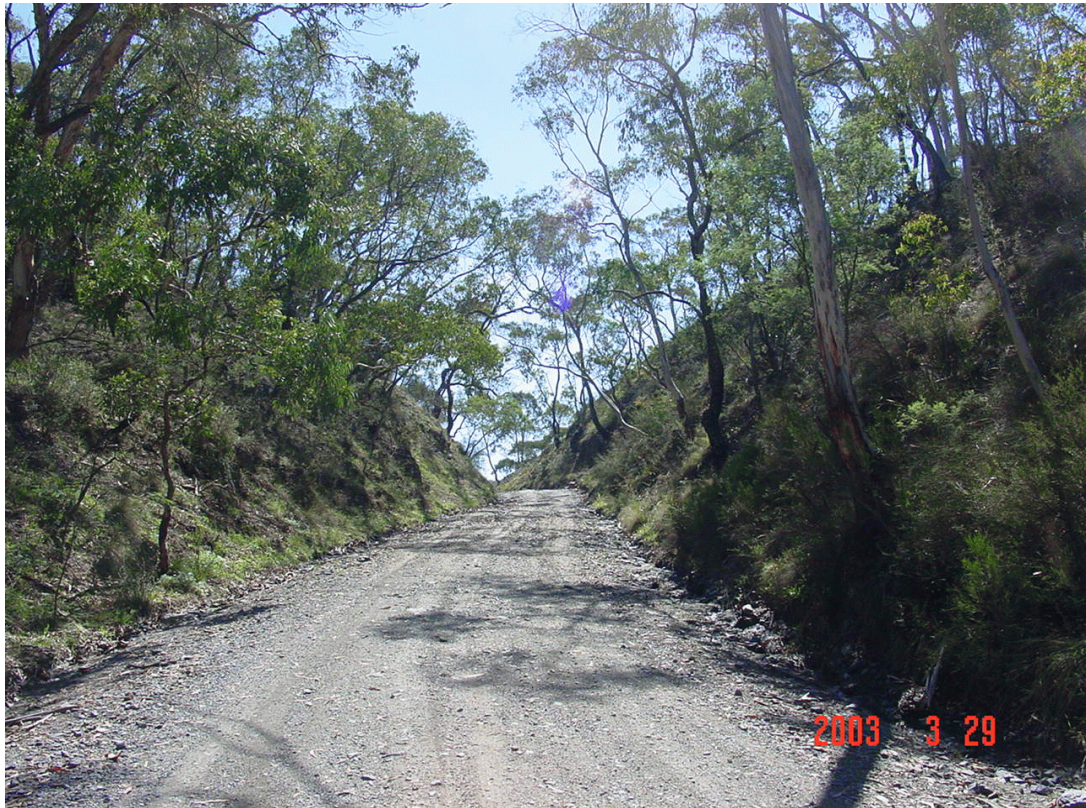
Figure 3.4 A remnant cutting on Mitchell's line of road as it rises from the Cox toward Solitary Creek. Cuttings such as this took an enormous amount of work and greatly lengthened the construction process.[S. Rosen, 2003]
