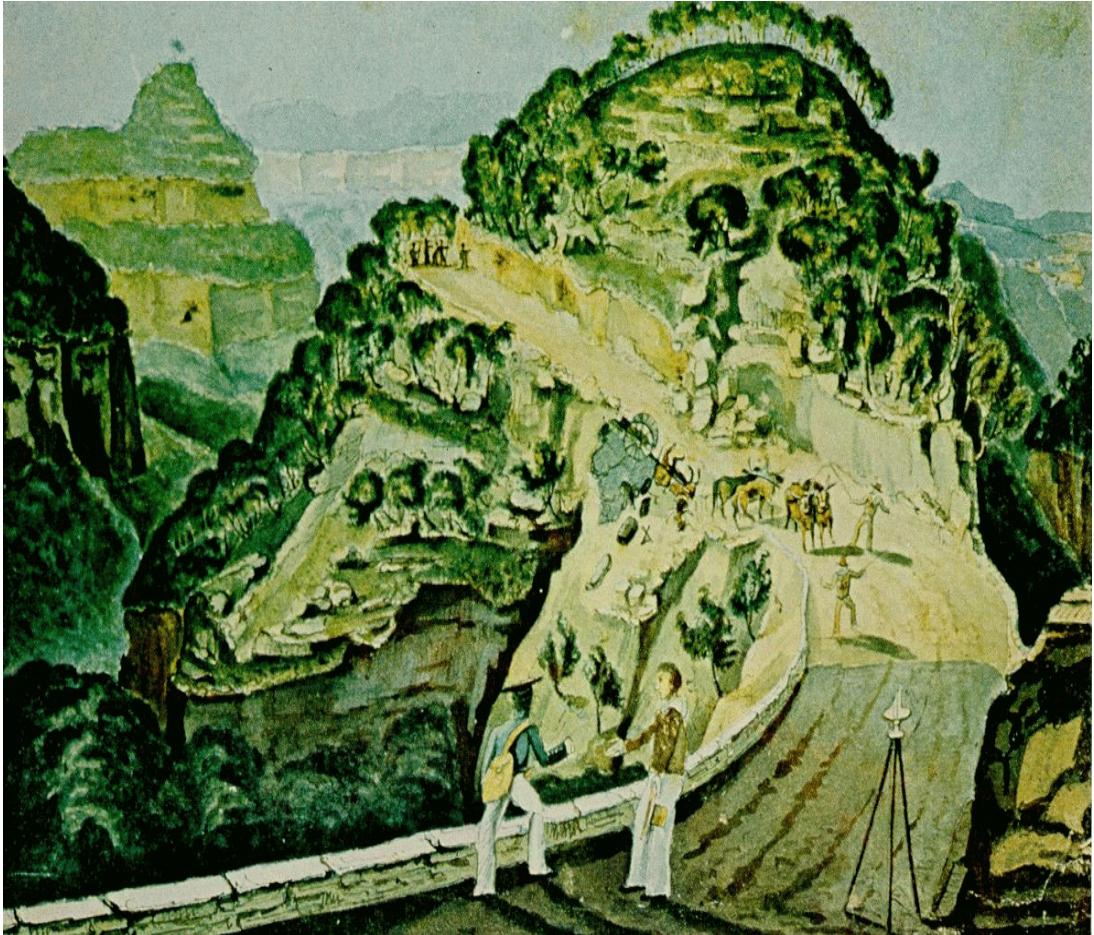
**Figure 4.9** A view of Mt Victoria by Surveyor William Govett. The pass is open, but adjustments continue. In the foreground is a surveyor with a theodolite. In the background cattle are falling over a breach in the wall. [ML SLNSW]

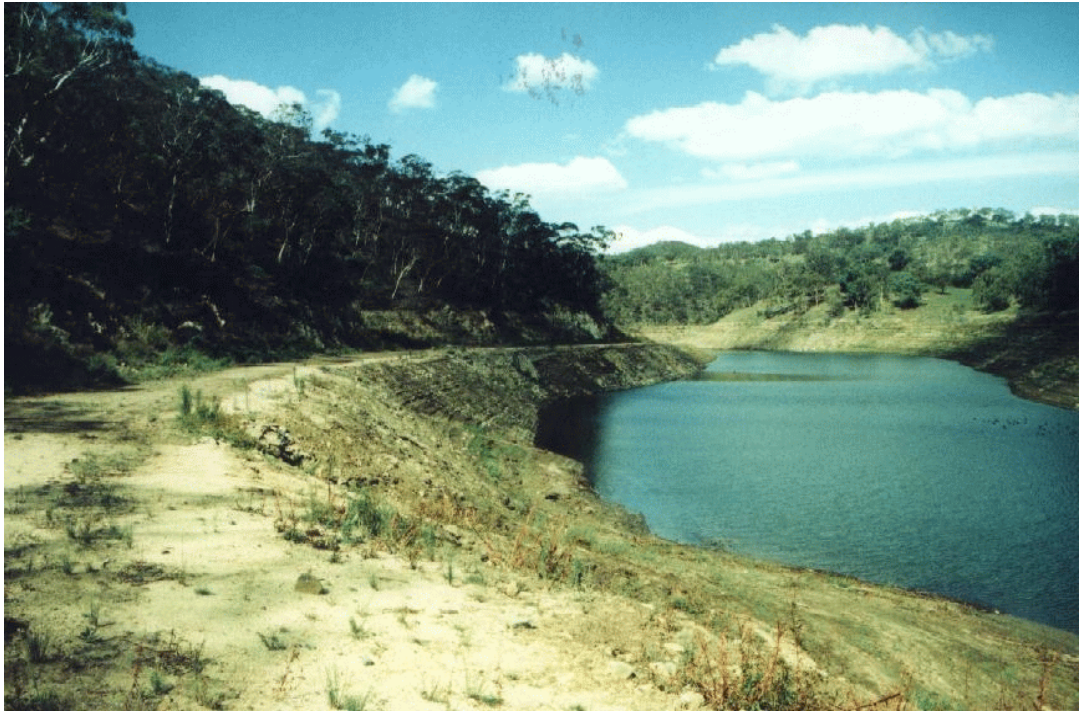
**Figure 4.10** A view of the stone walls constructed on Mitchell's new line as it approached the Cox's River in the mid 1830s. Taken from the west looking away from the No.2 Stockade site toward Farmer's Creek. [C. Liston 2003]

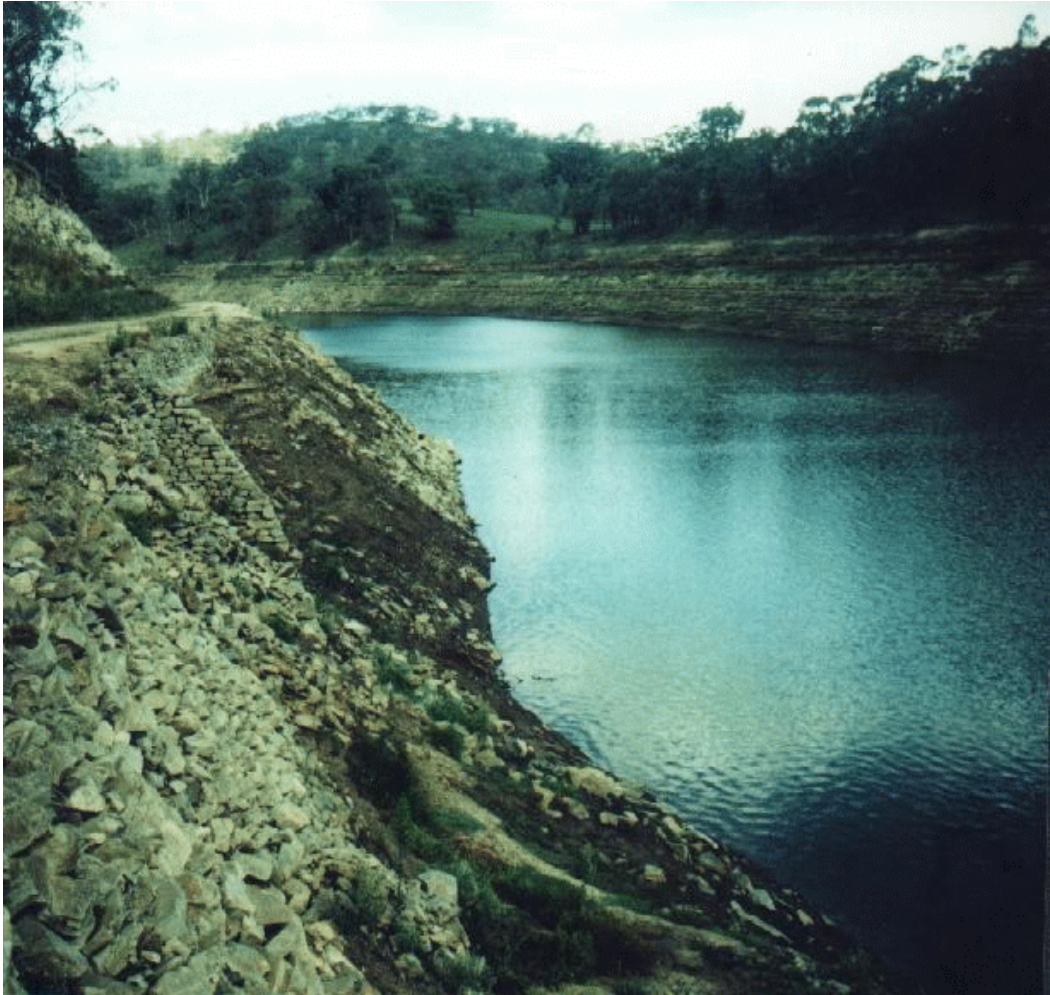
**Figure 4.11** A closer view of the remnant walls between Cox's River and Farmer's Creek [C. Liston, 2003]

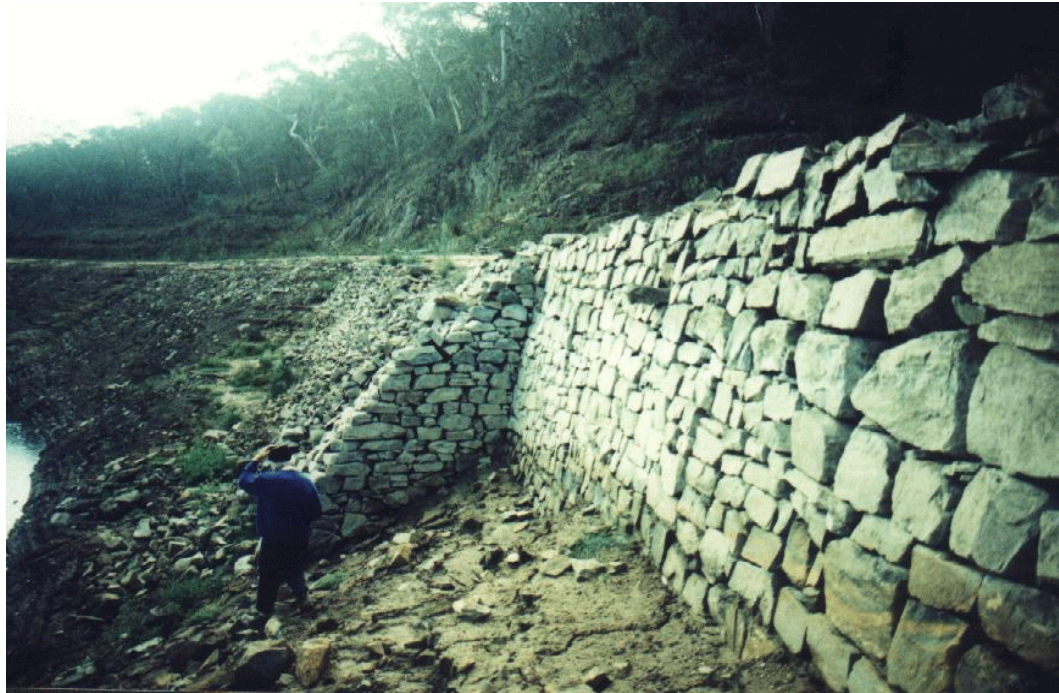
**Figure 4.12** This substantial stone wall uncovered during the drought of 2002 and 2003 was constructed near a water course on the road between Farmer's Creek and the Cox. It indicates the massive amount of work required to meet what are described in the correspondence as relatively minor problems, in this instance Mitchell's statement the '... a small water course has given way'. [C. Liston, 2003]
